Bush Beans Case Study

Customer: Bush Beans

Application: Steam Boiler

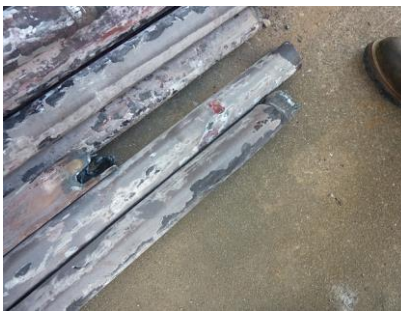
Boiler Tubes (before)

The Challenge: Bush Beans were experiencing significant scale accumulation on their fire tube steam boiler despite the use of scale inhibiting chemicals. Bush Beans adhere to a strict blow down schedule as part of their planned maintenance program.

Bush Beans had to take their boiler offline every 6 to 12 months in order to inspect and descale the water drum and tubes.

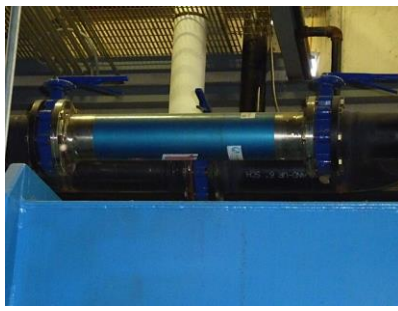
6" NaturalSof installation

The Solution: Fluid Dynamics were called in and having assessed the system recommended the installation of a 6" NaturalSof on the main feed to the boiler.

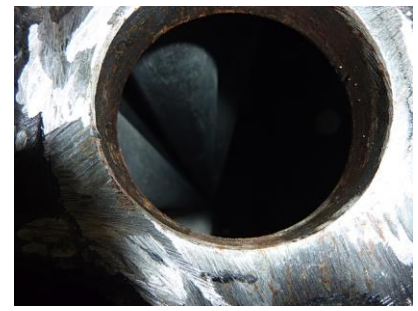
View inside the water drum (after)

Results: Following the installation, the boiler was opened for inspection 6 months later. The reduction of scale was very apparent, any scale that was present was soft and easily washed away without the use of chemicals whereas in the past chemicals and mechanical methods (chipping hammers etc.) had to be used to remove a hard scale accumulation. Bush Beans are delighted with the reduction in maintenance and associated down time. As expected, energy costs are down due to the savings associated with operating a scale free system.
